December 22, 2015

Reference No. 1537191-001-L-Rev0

HODGSON ROAD LANDSLIDE

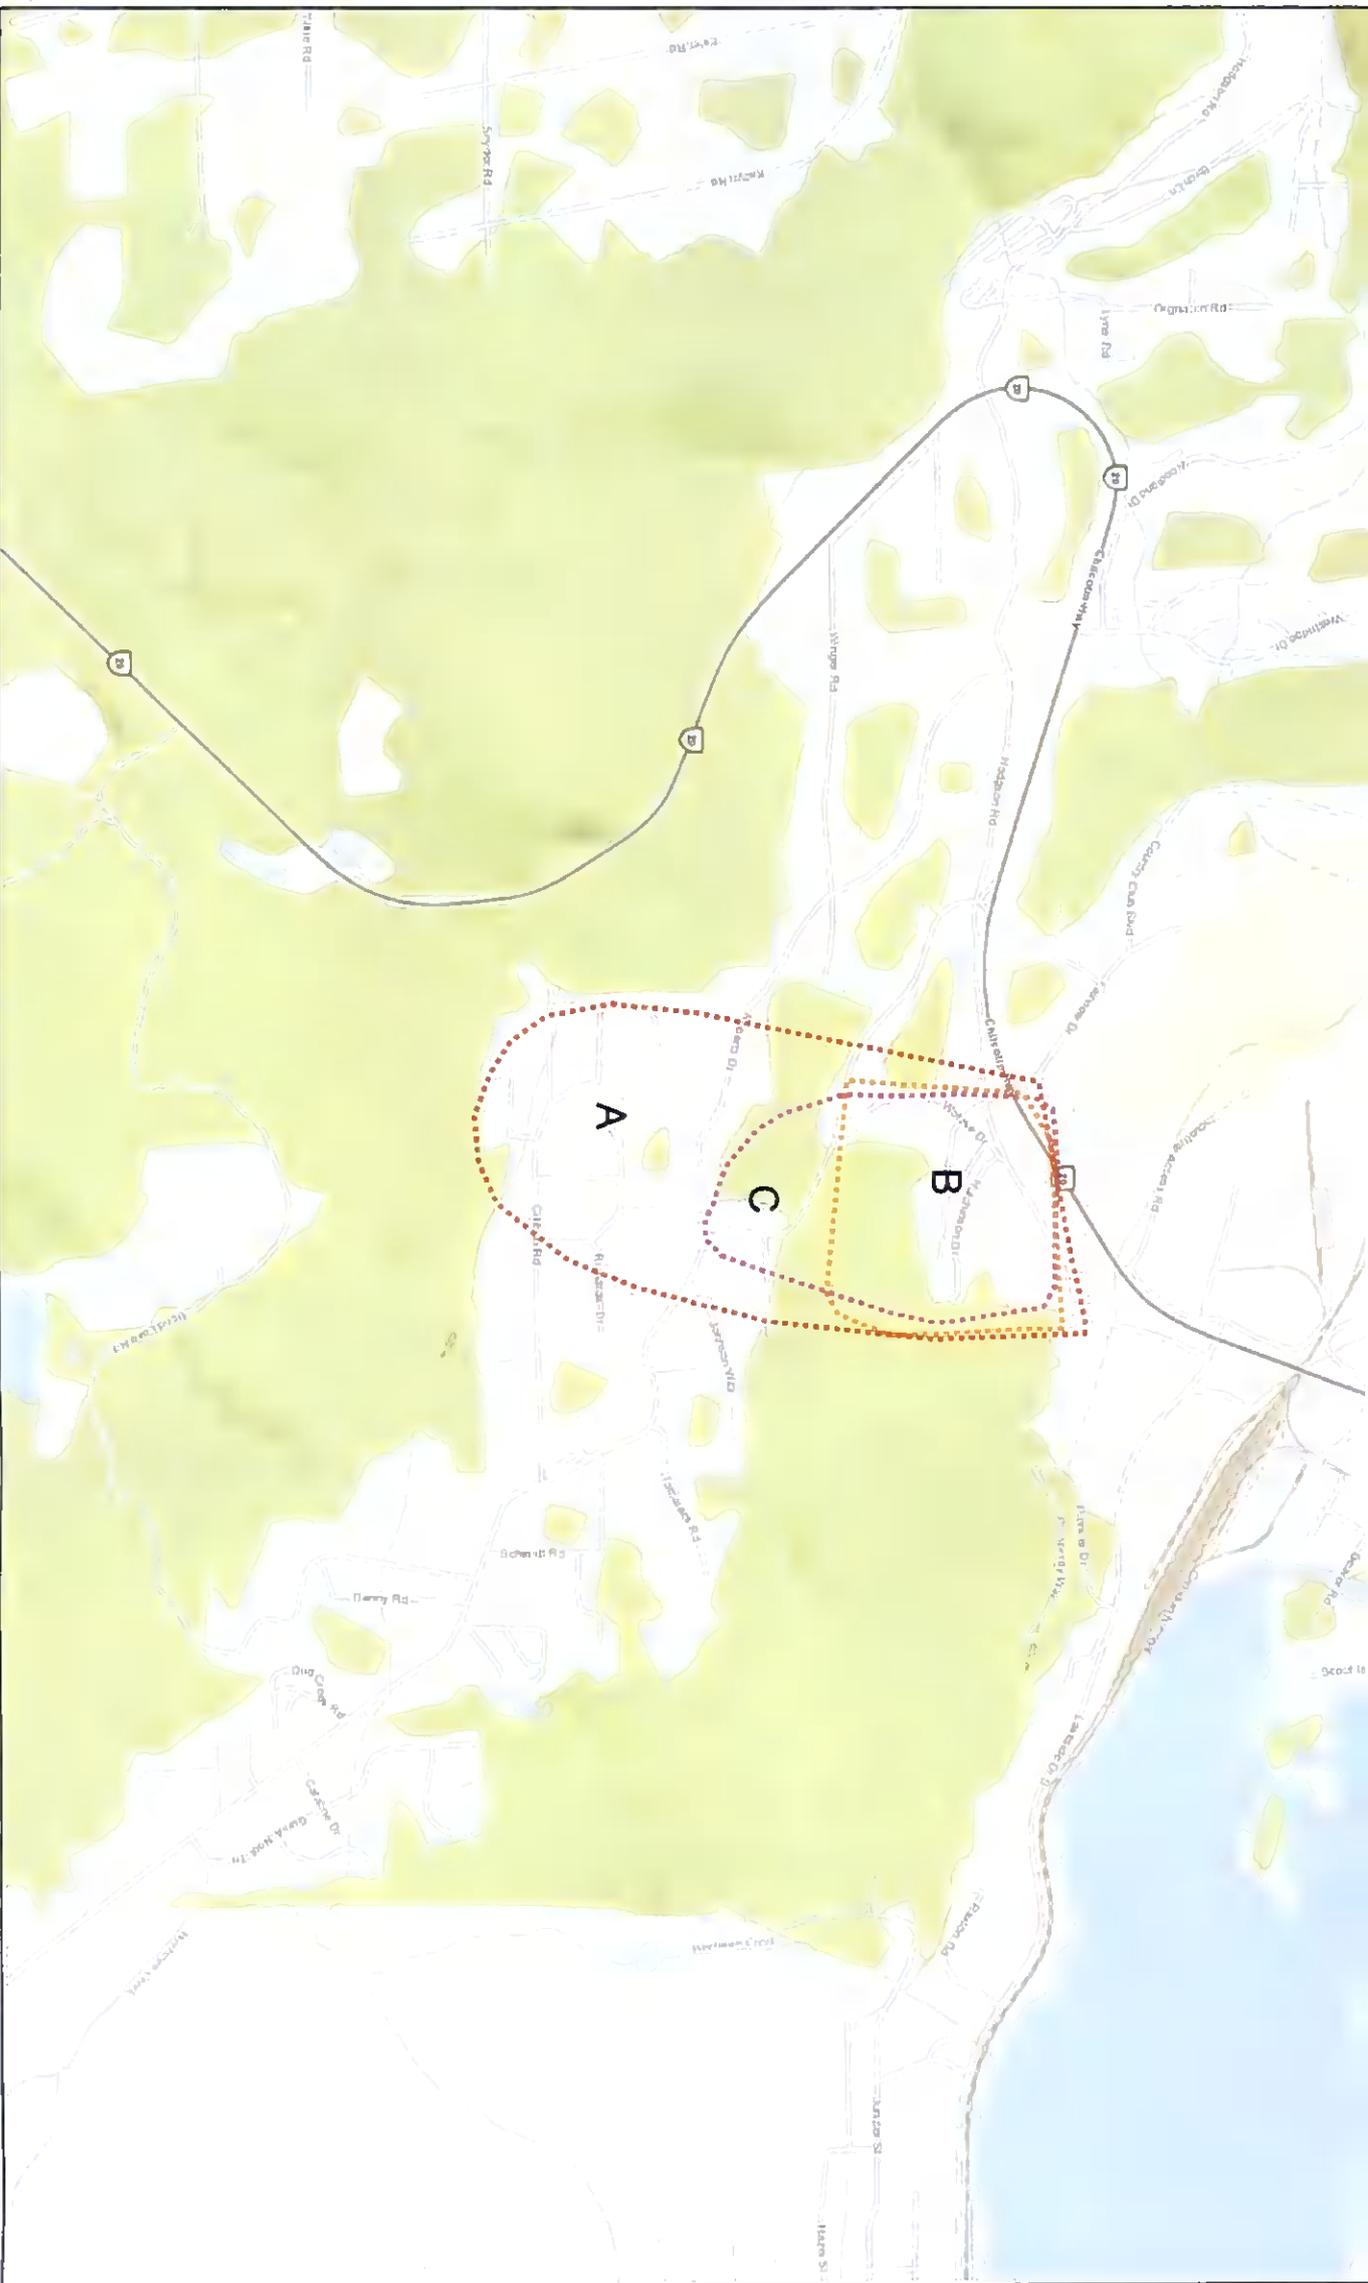
Attachments: Figure 1: Hodgson Road Landslide – Inferred Boundaries

Since 1993, the Hodgson Road Landslide has moved episodically, with total recorded displacements now in the range of 0.3 to 0.4 m. Over the last three years the landslide movements have reportedly become increasingly severe with time. It is understood that the landslide movements are damaging a business centre, a seniors/adult residential complex, a single family house (now abandoned), Highway 20, Dog Creek Road, FortisBC gas lines and City of Williams Lake water mains. The area of ground movement, originally measured at 600m by 600m, has now expanded upslope by a further 300m into the lower part of the Dog Creek Road residential subdivision. The areas of detected movement in 1999 and 2014 are shown in Figure 1, together with the interpreted full outline of this ancient slide mass.

The area of detected ground movement in 1999 is shown in Figure 1. At that time, all the detected/measured movement was north of Dog Creek Road. The overall ancient landslide may be much larger than the area of detected movement as the toe of a large slide can move faster and sometimes independently of the overall slide mass.

The distress reported near the intersection of Dog Creek Road at Roberts Drive (heave, gas pipe line and distressed house) suggests that the slide area affected by ground movement has retrogressed roughly 300 m upslope, well into the CRD and the lower edge of the upslope rural subdivision.

Outline	Description	Rough Dimensions	Basis for Assessment
A	Inferred Ultimate Limit of Landslide (1997)	750m x 1500m	Landform and Monitoring
B	Detected Limit of Ground Movement (1999)	600m x 600m	Monitoring and Observed Distress
C	Detected Limit of Ground Movement (2014)	600m x 900m	Monitoring and Observed Distress
